Failure modes and mechanisms in gray cast iron pipe

Makar, J.M.; Desnoyers, R.; McDonald, S.E.

NRCC-44218

A version of this paper is published in / Une version de ce document se trouve dans :
Underground Infrastructure Research: Municipal, Industrial and Environmental
Applications, Proceedings, Kitchener, Ontario, June 10-13, 2001, pp. 1-10

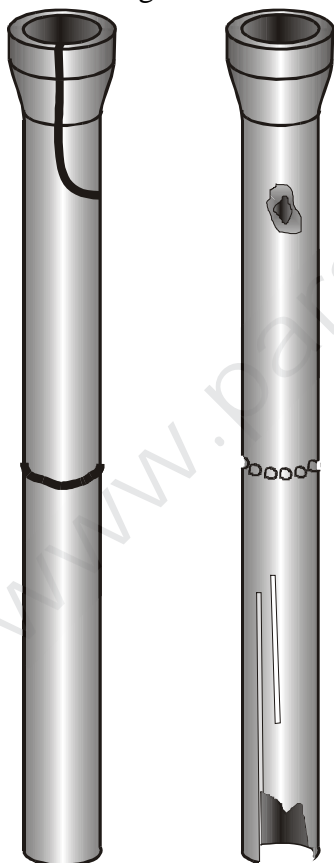
Figure 1. Failure modes for small (<380 mm) diameter pipe. Left pipe: bell splitting at top of pipe, circumferential cracking at middle of pipe. Right pipe: corrosion through-hole at top of pipe, chain created corrosion pitting at middle of pipe, elongated corrosion pitting with blow out hole at bottom of pipe. Generally these failure modes will not be seen on the same pipes.

Circumferential cracking is the most common failure mode for small diameter (<380 mm diameter) gray cast iron pipes (Figure 1). Typically this type of failure is caused by bending forces applied to the pipe. The resulting failure occurs in a manner similar to a twig snapping, with the failure crack propagating across the circumference of the pipe. This type of failure may also be caused by soil movements producing tensile forces on the pipe, producing a simple tensile failure.

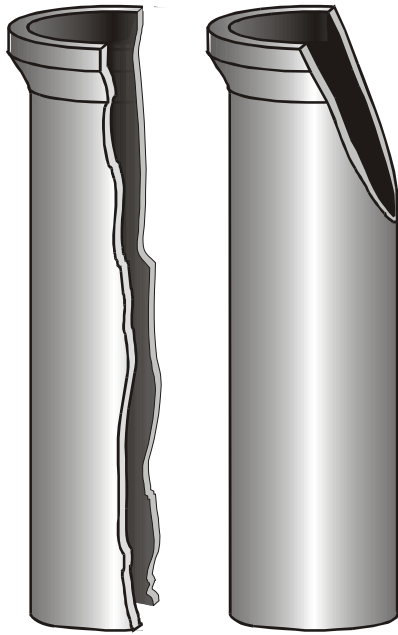
Figure 2. Failure Modes for large (>500 mm) diameter pipe. Left pipe: Longitudinal splitting. Right pipe: Bell shearing. Corrosion pit failure modes are also common on these pipes.

Large diameter pipes generally have too high a moment of inertia to produce the circumferential failures shown in Figure 1. However, large diameter gray cast iron pipes do fail by having a section of the bell shear off as shown in Figure 2. A possible cause of this failure mode is compressive forces pushing the spigot of a pipe into the bell of the next pipe in the pipeline. However, bending forces are more likely to be the cause of this type of failure. Simple compressive loading would tend to produce a crack that propagates down the length of the pipe, but a bending force would produce the type of shearing shown in the figure. An example of this mode was seen in a 1998 failure of a 914 mm diameter main in Boston.

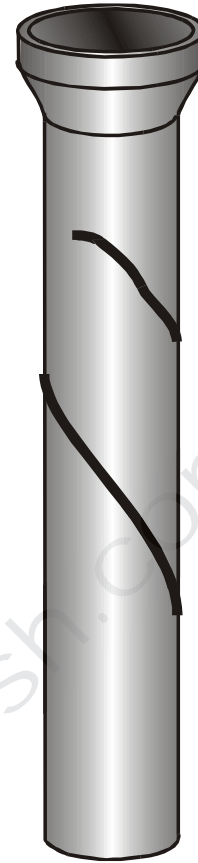
Some medium (380 mm –500 mm) diameter pipes experience a unique failure mode where the crack in the pipe appears to start in a circumferential fashion and then propagates down the length of the pipe in a spiral fashion. This failure mode has been seen in Des Moines, St. Louis and Ottawa. In the two former cases the failures were associated with pressure surges. The appearance of this failure mode also suggests that the failure is produced by a combination of bending forces and internal pressure.

Figure 3. Spiral failure mode in mid-diameter (380 mm –500 mm) pipe. Corrosion pitting failures have also been seen in these pipes.

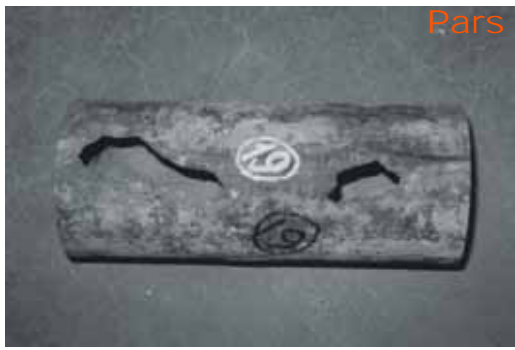
Figure 4. Heavily corroded gray cast iron pipe. (City of Toronto)

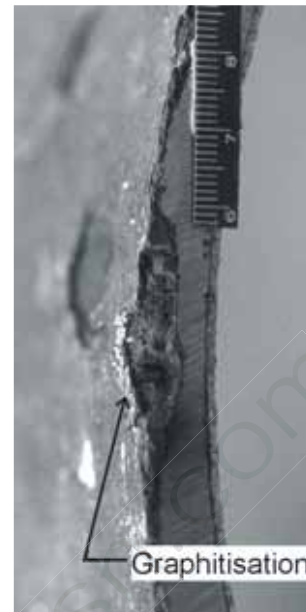
it is clearly still a possibility. Visually undamaged ductile iron pipes should not, therefore, necessarily be assumed to be without corrosion damage.

Figure 5. Cross-section of ductile iron pipe showing graphitisation. (City of Ottawa)

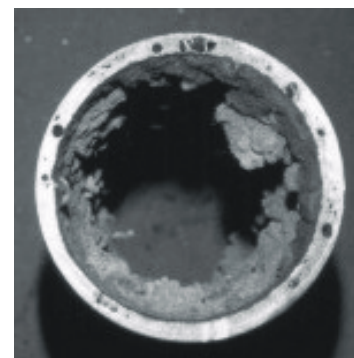
Figure 6. Pit cast pipe showing porosity (black dots on cut metal surface). (City of Toronto)

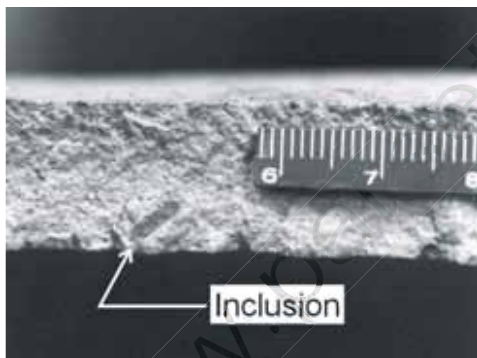
Inclusions are unintentional objects created in metals during manufacturing that are not part of the continuous fabric of the material (Figure 7). They weaken the pipe metal by acting as crack formers, reducing the total cross-section of metal in the pipe and producing stress concentrations. The inclusion shown was formed from iron oxide, but a more common inclusion is undissolved ferrosilicon. The latter material was a common means of adding silicon to cast iron, which lowers the melting point of the metal and makes it easier to cast. However, if the metal cools too quickly, the ferrosilicon will not completely dissolve, leaving behind a black, spherical inclusion.

Figure 7. Inclusion along a fracture surface. (City of Ottawa)

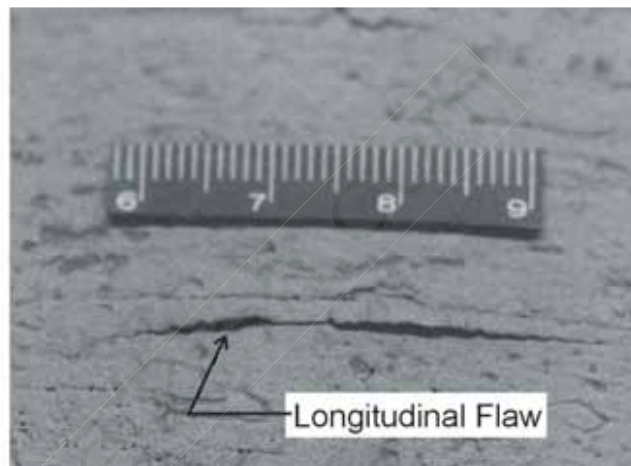
Spun cast pipes generally appear to have fewer casting defects than pit cast ones. However, they do experience a variety of defects that can only be produced by the spin casting process. Figure 8 shows an example of a longitudinal surface defect. The particular pipe photographed here and in Figures 9 and 10 had numerous examples of this type of defect on its outer surface, which would have been in contact with the pipe mould. In some cases these defects were detached from the pipe surface as shown in Figure 8, while in others they appeared only as parallel lines on the pipe.

Figure 8. Longitudinal flaw in spun cast pipe. (City of Ottawa)

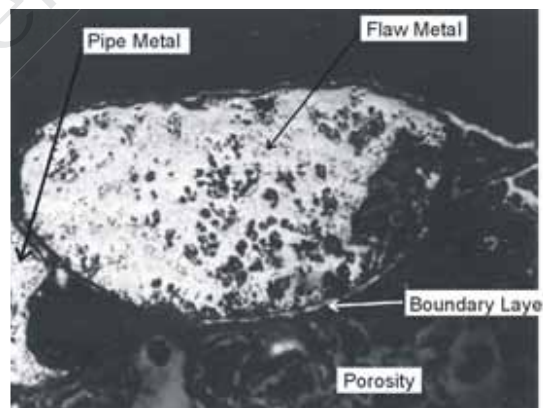
Figure 9 shows a cross-section of the pipe wall across one of these longitudinal flaws. Both the flaw material and the pipe itself are composed of cast iron. However, a noticeable pore is located di-

rectly below the flaw and an iron oxide boundary layer was identified between the flaw and the pipe wall. The presence of the boundary layer and the semi-circular shape of the flaw cross-section suggests that the flaw material solidified before the bulk of the pipe. The iron oxide layer was produced by contact with the air as the flaw metal cooled, while the elongated shape and the observed cross-section was produced by a combination of surface tension and the centrifugal “forces” produced by the spinning mould.

Figure 9. Cross-section of longitudinal flaw. (City of Ottawa)

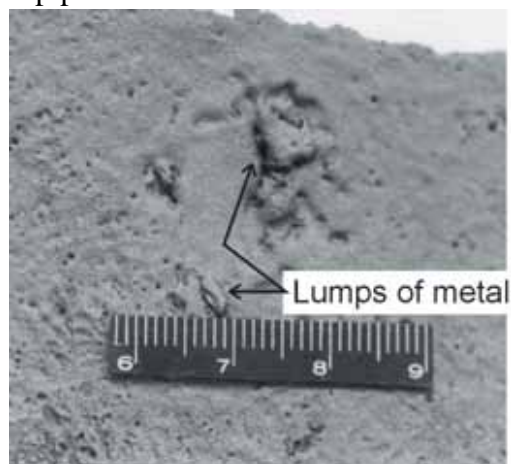
The same pipe also had lumps of metal standing proud of the pipe surface (Figure 10). Normally molten metal would be spread out by the spinning process. The presence of the lumps suggests that the pipe metal was cooler than desirable during the casting process, allowing the lumps to solidify in place.

Figure 10. Lumps of metal on pipe surface. (City of Ottawa)

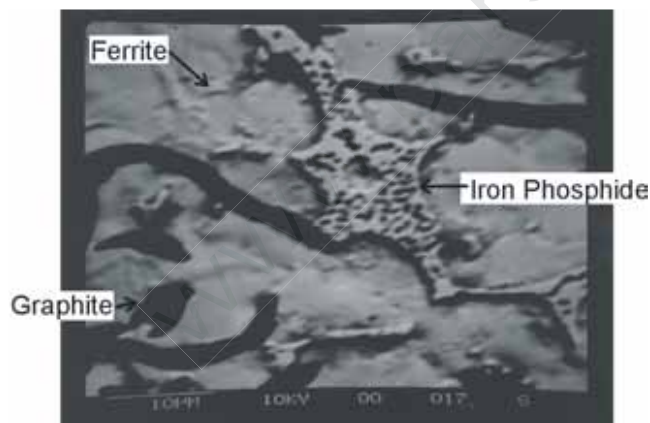
A final type of manufacturing flaw observed in a number of cast iron pipes is the presence of iron phosphide networks throughout the pipe metal (Figure 11). Phosphorus was added to molten cast iron in order to lower the melting point of the metal and its viscosity. This meant that lower casting temperatures could be used, reducing the total cost

Figure 11. Portion of iron phosphide network within pipe metal. (City of Moncton)

of manufacture. However, the presence of phosphorus can also produce the type of network shown in Figure 11. This iron phosphide compound is even more brittle than gray cast iron and its presence weakens the pipe. Most modern steel and cast iron manufacturing attempts to minimise the phosphorus content, with specifications calling for a value that depends on the quality of the steel but is typically

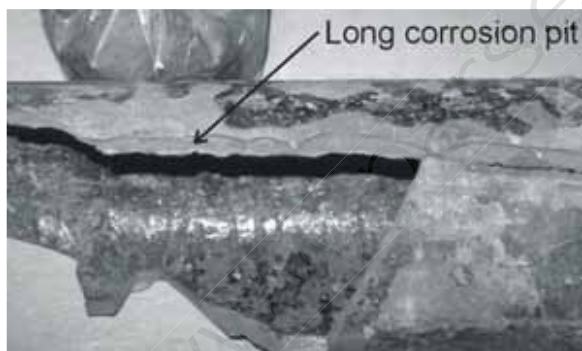
Figure 12. Elongated corrosion pits caused by scratching pipe. (City of Ottawa)

iron and ductile iron pipes have been observed to corrode without noticeable coating damage, but damage to the coating enhances the probability of significant corrosion in the damaged area. In the case shown in the figure, the long thin pits corroded to the point where the metal was paper thin at the bottom of the pit. A pressure surge caused the pipe to fracture along the pit, followed by a full blow out. Similar damage has been observed on ductile iron pipes from the City of Toronto. In this case an unpadded chain was placed around the pipe when it was being moved. Each link of the chain damaged

the pipe coating, resulting in a series of corrosion pits located around the circumference of the pipe (see Figure 1 for a sketch of this failure).

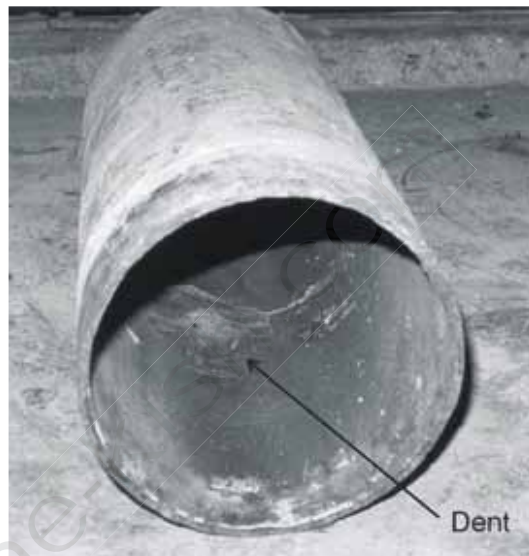
Another common source of failures due to human error is third party damage. Excavations made on or near pipelines without accurate knowledge of their location frequently causes pipeline damage or failure (Figure 13). This type of failure is common to all buried utilities, including both pipelines and other services such as telephone and television cabling.

Figure 13. Dent and hole in ductile iron pipe due to third party damage. (City of Toronto)

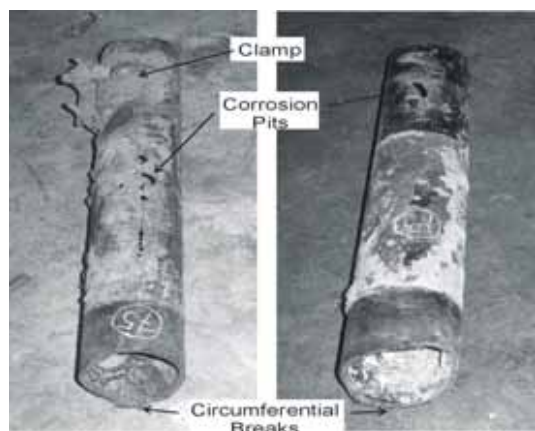
Sometimes problems can be perpetuated through simply following a water utility's standard operating procedures. Figure 14 shows two pieces of a single pipe that experienced four distinct failures in the length shown. The back of the left pipe section was connected to the front of the right one by the clamp that is shown in the picture. Each of the failures was associated with corrosion pitting. These failures appear to have taken place over a significant length of time, with the response to the first three cases being to place a stainless steel clamp over the damaged area. The pipe was not removed until the very long corrosion pit on the left section developed.

An examination of the damage to the pipe makes it clear that it was located in a very corrosive environment. The stainless steel clamps held the pipe together, but did not prevent further corrosion in a nearby location. In fact, a number of pipe failures observed by NRC occurred next to previous failures covered by stainless steel clamps. It is possible that some aspect of the repair procedure itself may be responsible for the subsequent failures. More research is required to investigate this possibility.

Figure 14. Multiple failures on same pipe. (City of Toronto)

This result suggests that alternate approaches to simple clamping for dealing with corrosion related failures may be desirable. One method used by some cities is to add a sacrificial anode to the pipe at the site of each failure. This should protect the pipe for the duration of the anode's life. The anodes can

also be checked and replaced if necessary on a scheduled basis, rather than through emergency repairs.

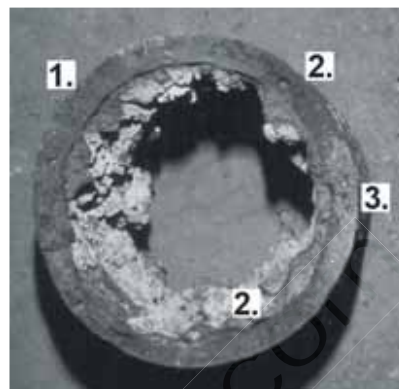
Figures 15 and 16 show two examples of multiple event failures. Their role in a pipe failure can be detected by carefully examining the fracture surface of the pipe. In the case of the pipe shown in Figure 16, only about 80% of the pipe circumference had been cracked through at the time it was removed from service. The intact circumference, labeled as region 3 in the figure, was broken in the laboratory using a stress testing machine. Examination of the entire fracture surface afterwards showed that two cracking episodes had taken place while the pipe was in use. Region 1 was covered with a relatively thick layer of corrosion products that had an orange colour and regions of gray material. The regions labeled 2 in the figure had a much thinner layer of corrosion product with a dark red colour. The gray colour of the graphite flakes that give gray cast iron its name could also be seen below the corrosion products.

Figure 15. Multi-event circumferential failure. "1" indicates the first cracking event, "2" indicates the second cracking event and "3" indicates the region that was intact until broken in the laboratory. (City of Toronto)

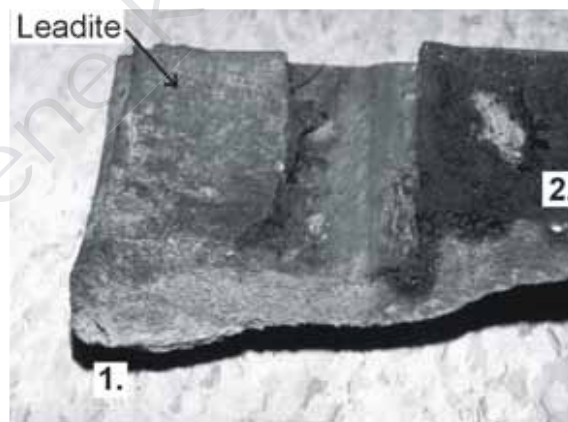
Although the pipe in Figure 16 clearly shows that not all circumferential failures require complete cracking around the pipe, visual identification of different cracking episodes can be very subjective in nature. Further evidence for this phenomena is provided by elemental analysis of the fracture surface.

Figure 16. Multi-event bell splitting failure. "1" indicates the start of the first cracking event at a small corrosion pit while "2" indicates the start of the second cracking event. (City of Ottawa)

In the case of Figure 16 the visual examination showed evidence of two cracking episodes, with one region near the bell having thick corrosion products and an orange-gray colour and the other region closer to the end of the crack having thin corrosion products with a dark red colour. An elemental analysis shows the presence of a number of elements on both regions of the fracture surface that are not present in the pipe metal. These elements were therefore acquired from the surrounding soil. However, the region with thicker corrosion products showed the presence of sulphur, aluminum, potassium and a high quantity of calcium, while the region with the thinner layer of corrosion products showed considerably smaller amounts of the last three elements and no sulphur at all. This difference indicates that the fracture surface under the thicker layer had been exposed to the surrounding soil for a longer period of time than that under the thinner layer, providing

further evidence for a multi-event cracking process. Elemental analyses have been done for other fracture surfaces with similar results.

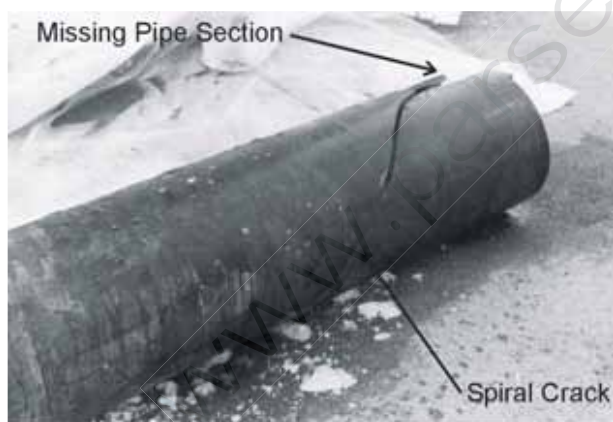
NRC was asked to conduct a failure analysis on a broken 410 mm water main in the summer of 2000 by the Regional Municipality of Ottawa-Carleton (now part of the City of Ottawa). This main had experienced a spiral failure (Figures 3 and 17) and appeared to have failed in a brittle manner. However, the Region's records showed the pipe as being ductile iron rather than gray cast iron. The unusual failure mode, the uncertainty in the records and the need to determine the vulnerability of the rest of the line led to the need for the failure analysis.

Figure 17. Medium diameter pipe failure. (City of Ottawa)

The first step in the examination was to cut up the pipe and expose the fracture surface. No evidence for a multi-event failure was seen, but the fracture surface did show a change in the direction of the fracture part way through the pipe (Figure 18). This change in the direction of the surface had not been seen in other pipes that had been investigated by NRC.

The analysis concluded that the failure was due to the manufacturing defects in the pipe. The inherent

resistance of the pipe to bending was marginal at best compared to the values required by the applicable standards. The frequency of the observed defects was such that there was a very high likelihood of one occurring at the failure site. The combination of a weak pipe material and an inclusion, longitudinal flaw or cluster of pores lowered the pipe's resistance capacity to point where the failure occurred.
